## PROJECT: NIHON UNIVERSITY NEWCASTLE CAMPUS

### Monthly Project Control Group Report

| Report No. | 13 |
| Prepared By | Ben Moss (Built Pty Ltd) |

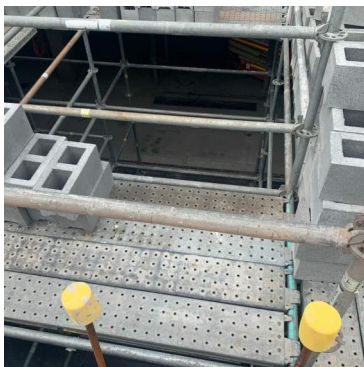
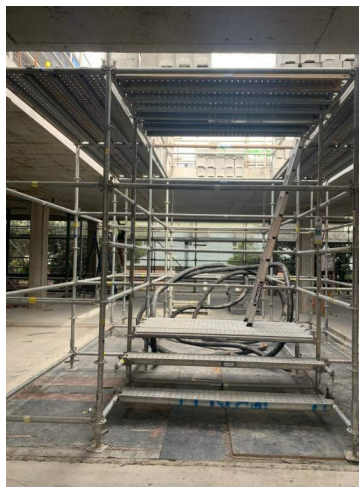
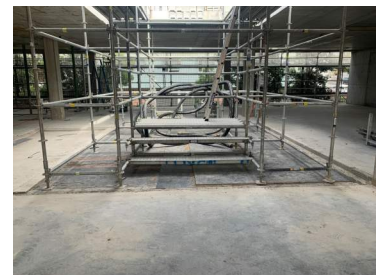
**Action description:** Exclusion zones to be created around scaffold to L3 terrace peno area

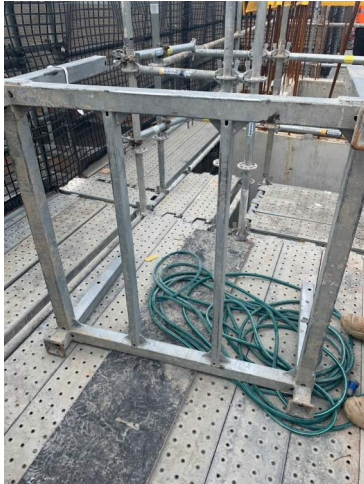
**Action description:** Scaffold stillage to be relocated to provide clear access

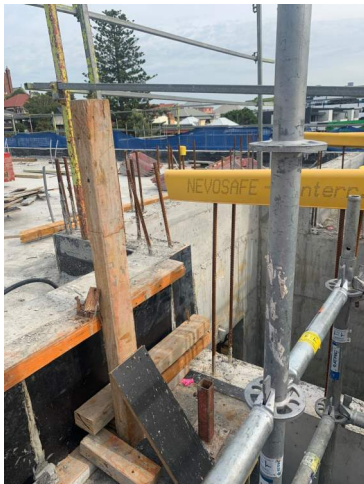
**Action description:** Bar cover to be re installed on lift shaft walls to Roof Level

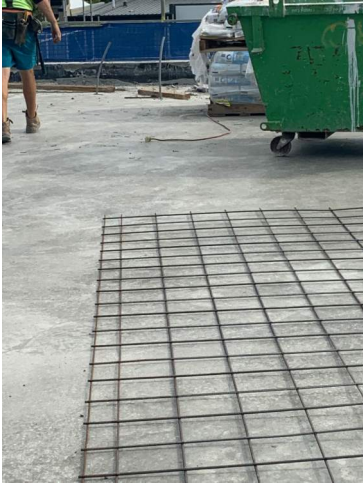
**Action description:** Temp power board required to Roof Level Education

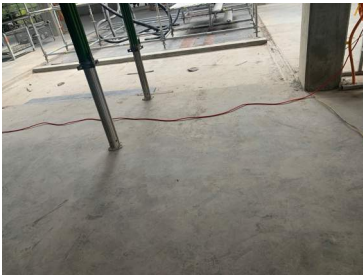
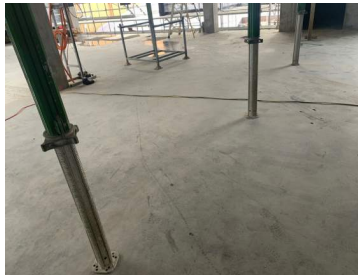
**Action description:** Lead stands to be used on Level 4

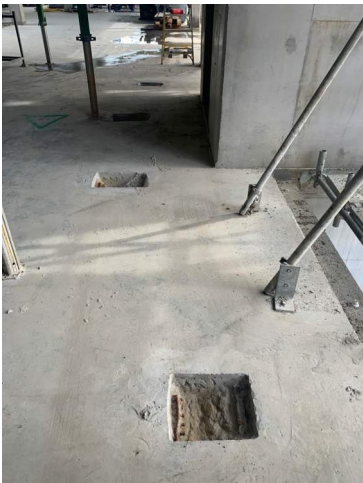
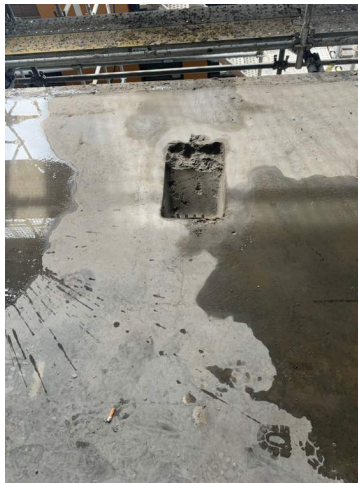
**Action description:** Pan covers required to L4

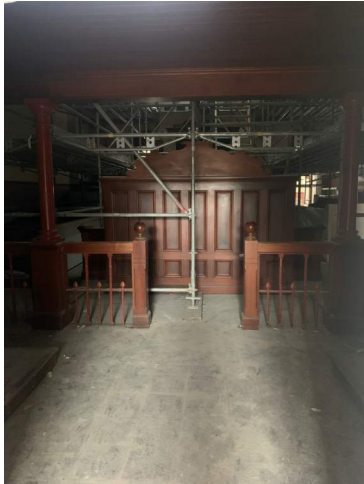
**Action description:** Lighting required for main courtroom

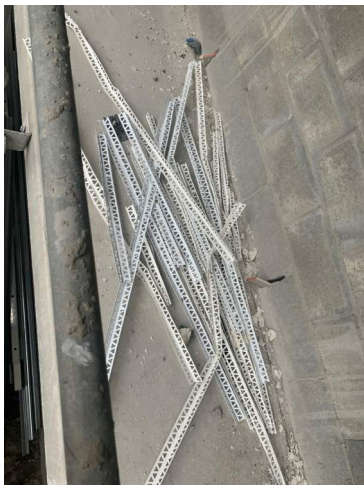
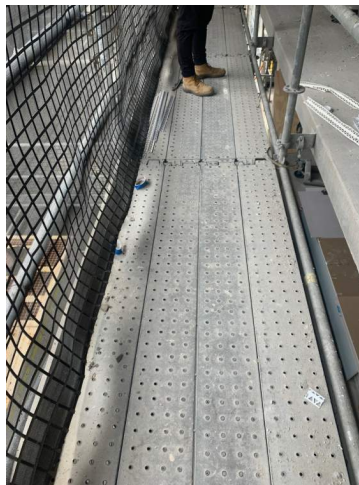
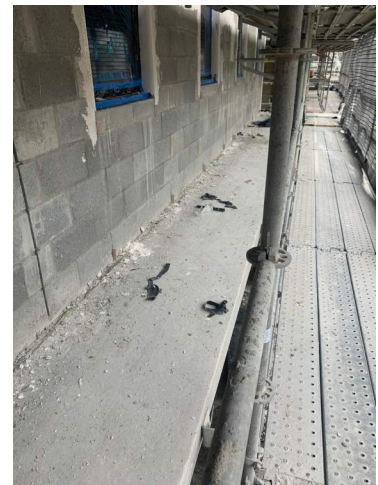
**Action description:** Render angles, tape to be cleaned off ledge and scaffold

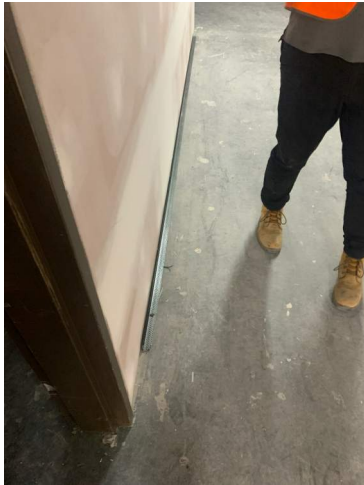
**Action description:** Gyprock angles to be removed from access corridors

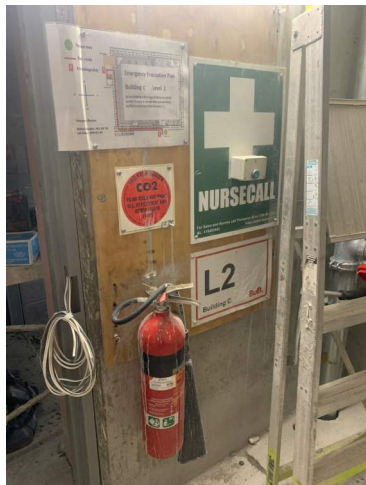
**Action description:** Ladders to be removed from L2 Stairs preventing access to nurse call

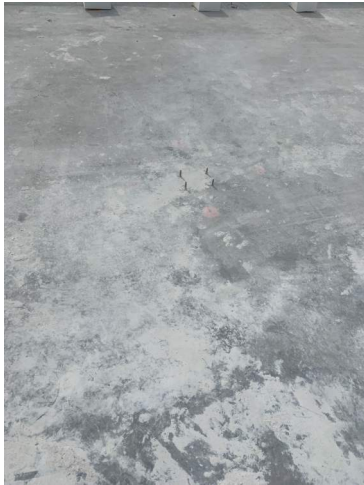
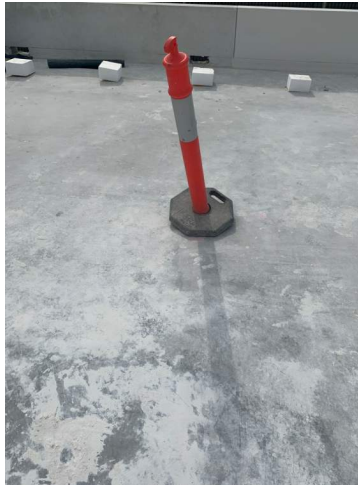
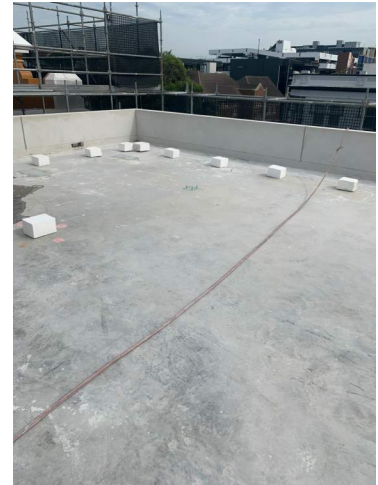
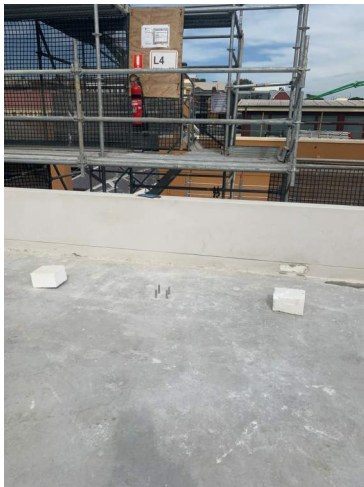
**Action description:** Cover missing on bolts on Roof Level Residential building

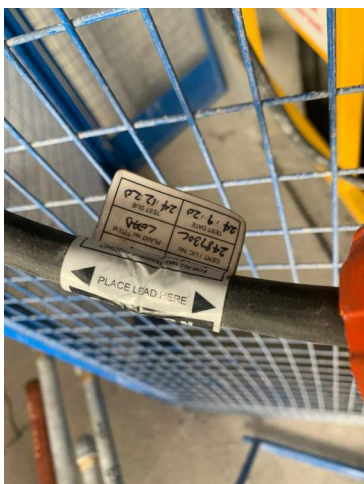
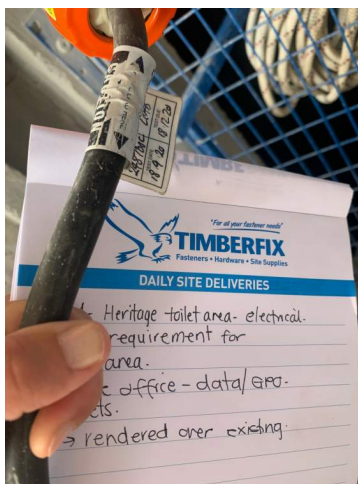
**Action description:** Kone power supply leads out of date to Roof Level

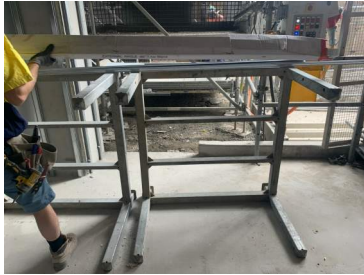
**Action description:** Scaffold stillages to be removed and relocated Blocking access to material hoist controls
