Our Ref: 81019007_006_LR_rev0
Contact: Bob Campbell

NIHON UNIVERSITY NEWCASTLE CAMPUS
REMEDIATIOPN ACTION PLAN – A TECHNICAL NOTE

A Coffey Environmental Scientist visited the site on 13 June 2012 to observe the exterior of the buildings and the site condition. Site photographs were taken during the visit, and are shown in Appendix D. The current site layout and features are shown on Figure 2.

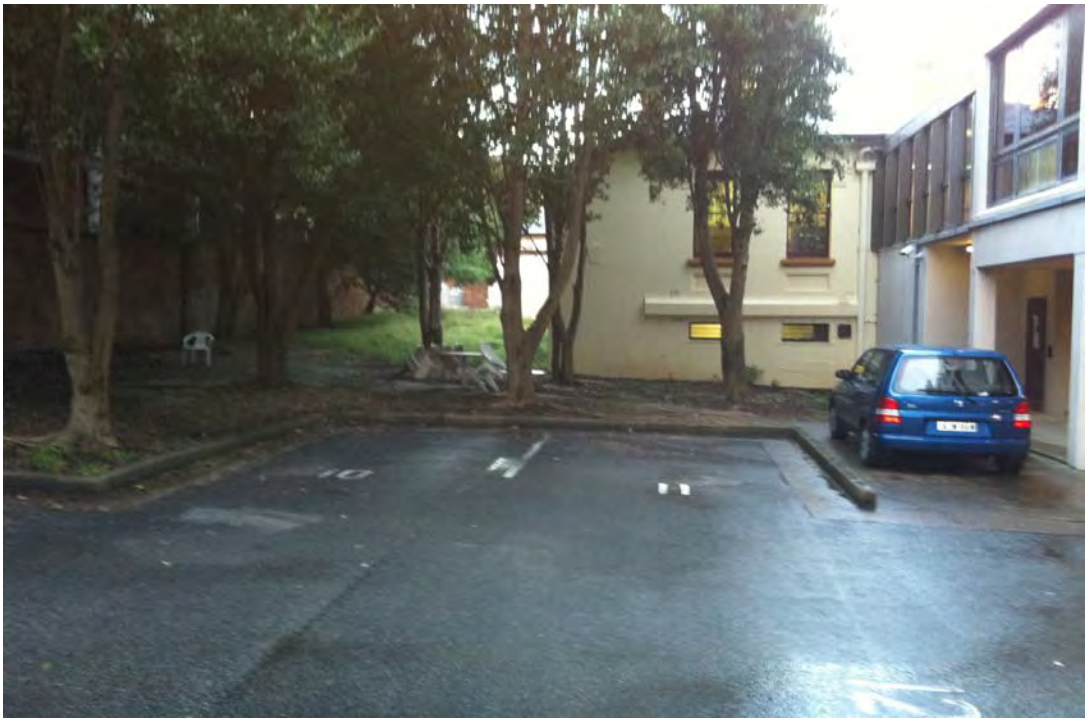
Photograph 1: 1890 Court House Building

Photograph 2: View from rear from the eastern wing

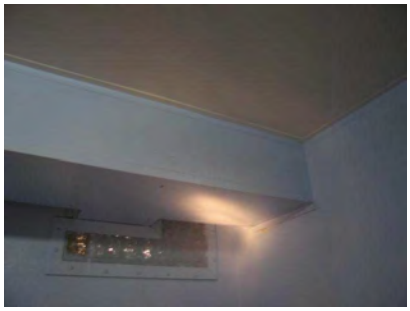
Item ref	6.2	Location	
Level	Level 2	Jury Toilets at rear of building	
Type	NT	Description of material	
Matrix	Hard	Presumed asbestos cement wall and ceiling linings and possible toilet partitions	
Condition	Not fully sighted		
Risk	R4	Comments / recommendations	
Sample ref	NT	Toilets could not be accessed and photo was taken through rear window. Asbestos cement sheet represents a minimal health risk if left undisturbed and is kept sealed with paint. Apply warning labels and avoid any abrasion by cutting or drilling.	
Date removed
